## The benefits of UV technology

## The technology

## Typical Hanovia UV installations in New Zealand

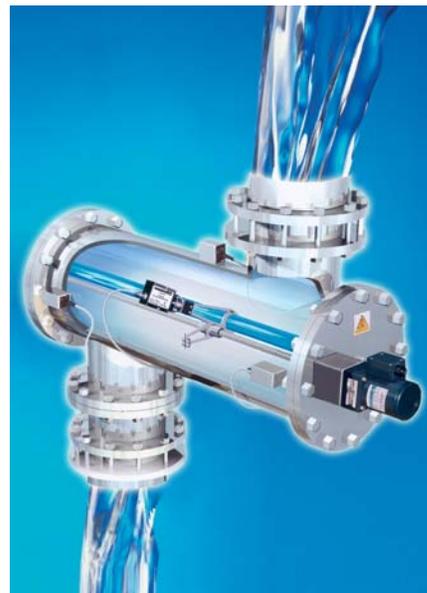
All Hanovia systems in NZ pools feature an automatic wiper on the quartz sleeve of the UV lamp ensuring optimum UV output at all times.

Most pool systems will have a single lamp with power inputs of 2.5 to 7.0kW. Larger systems may have four or even six lamps with energy inputs of up to 21kW. Most of this energy ends up as heat in the water and is therefore not a "real" energy loss to the pool, rather it reduces the energy used in pool heating.

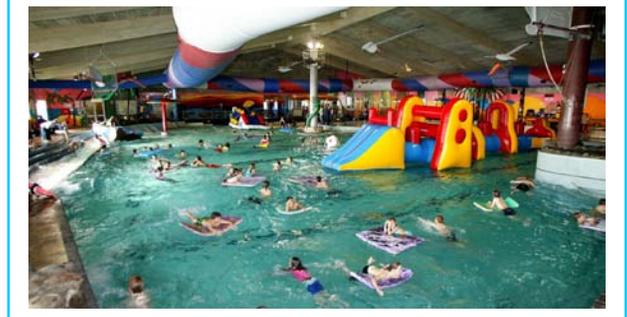
### New Plymouth Aquatic Centre (2004). UV systems installed on Main, Spa and Tots pools

Within a few days of turning the UV system on combined chlorine levels dropped in all three pools from over 2mg/L and they continued to fall for a week with a noticeable improvement in the pool environment to the satisfaction of users and staff. The water in the leisure pool became much clearer and less turbid. The busy main pool now operates at 0.2-0.4 mg/L combined chlorine and in the smaller pools combined chlorine is frequently almost non-existent. Deliberate dilution has been stopped as a result.

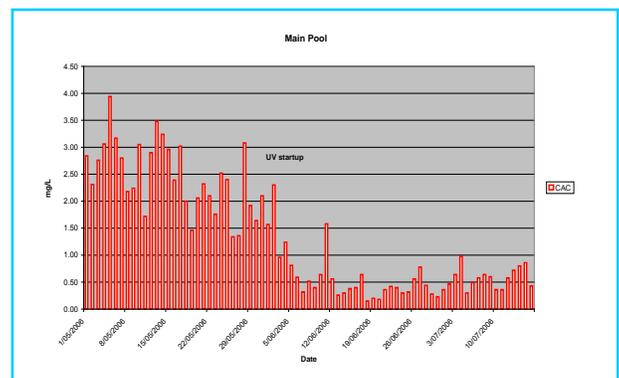
### Manukau City Lloyd Elsmore Park Recreation Centre, Pakuranga (2007)

The Leisure pool in this complex is very busy and it is reported to have the heaviest bather load in the Southern hemisphere. Even with constant dilution combined chlorine levels were as high as 5mg/L and the pool was selected by Manukau City as an excellent test case for the installation of a UV system. Results have been outstanding with chloramine levels being reduced by 90% even during the busiest periods. Dilution has been stopped with water savings of 100-500m<sup>3</sup>/week, resulting in a payback from the UV system of well under a year.
